de Valero, better known as the Alamo, for the last several years, when time allowed. Perhaps a year earlier I had noticed a listing in the calendar of the Bexar Archives for a document of 1810 about “the estimate for the completion of the construction of cannon for Valero mission.”<sup>2</sup> This was potentially interesting—if it described the construction of a cannon position at Valero, it would suggest that some of the fortifications at the Alamo battle of 1836 had been built as much as 26 years earlier. I took a quick look at the document, and it was *not* for the construction of cannon at Valero, but instead was an estimate for the cost of the materials to complete the *cañón* of the Valero church. That is, it was an estimate for the building of a roof over the nave and transepts of the unfinished church building, a virtually unknown project that itself was apparently never carried out.

### *The Valero Church*

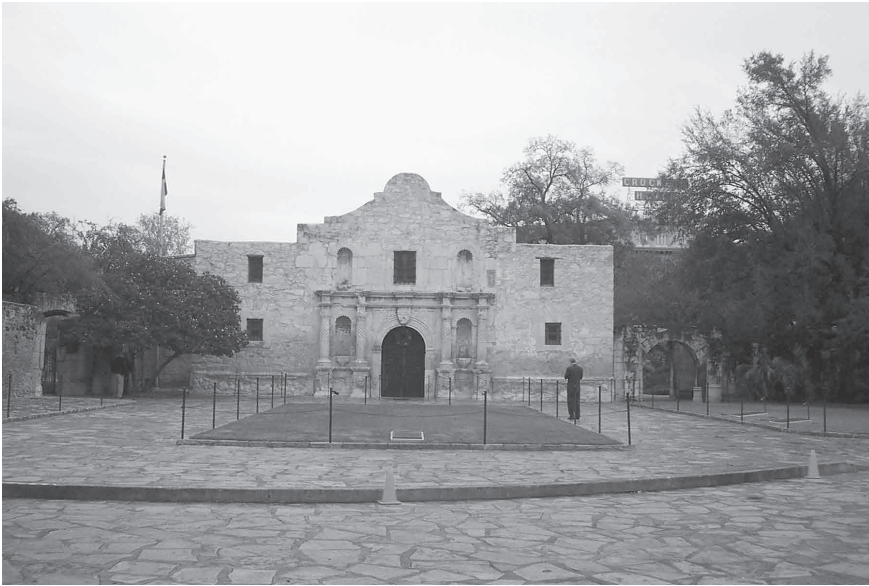
1. The mission church of San Antonio de Valero (the Alamo) today. The distinctive shape of the top of the façade is the result of the construction of a stone gable in 1850 to cover the end of the wooden roof built over the roofless building in that year by the U. S. Army so that it could be used as a military storehouse. Photograph by the author.

Antonio de Bexar. I have yet to find documents that indicate that the project was ever carried out (fig. 1).
